Docket No. 217 – Development and Management Plan Inspection

Northeast Utilities Service Company Certificate of Environmental Compatibility and Public Need for the construction of a 345-kV electric transmission line and reconstruction of an existing 115-kV electric transmission line between Connecticut Light and Power Company's Plumtree Substation in Bethel, through the towns of Redding, Weston, and Wilton, and to the Norwalk Substation in Norwalk, Connecticut.

Date: May 10, 2005

Location: 345kV XLPE Component

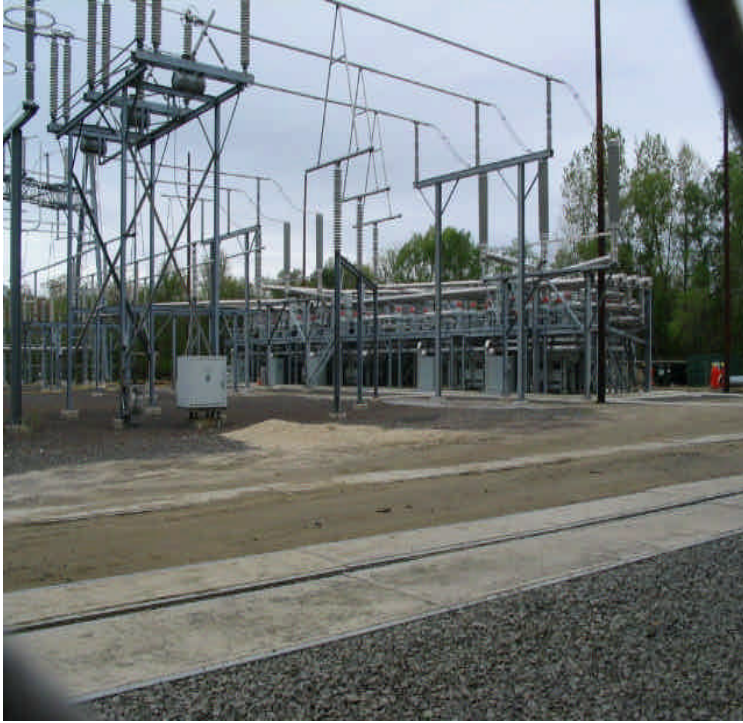
345kV XLPE: Photo on the left shows the Plumtree Substation yard where active work was mostly complete for this portion of the project. Photo on the right shows the vault 2a and b area which will be restored soon. Allow revegetation where feasible. 5/10/06

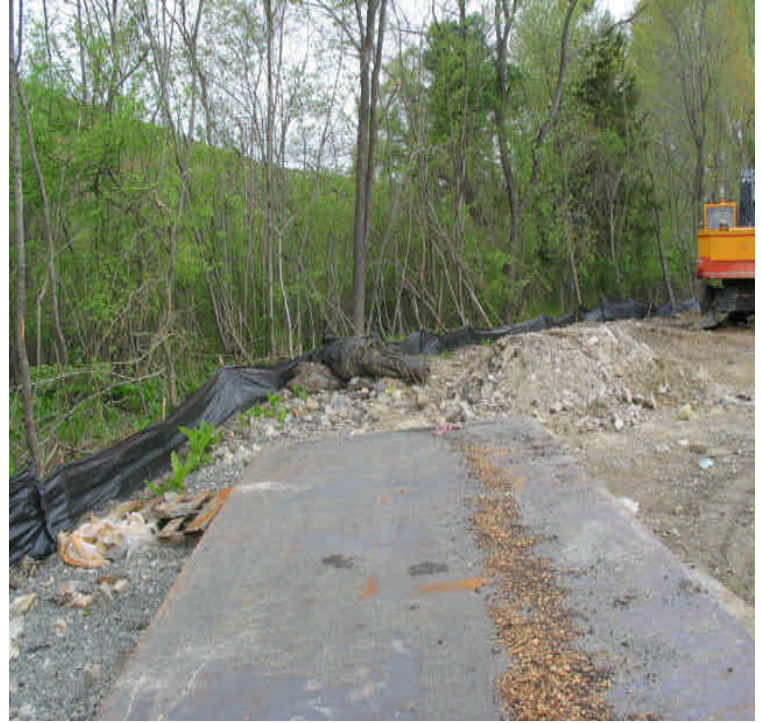
Areas of Inspection	Observation	Recommended Action	Corrective Action
	removed. 4/12-5/10/06 - Work will return here eventually to connect to the trench. Ruts will be repaired at that time. 5/10/06	this area since the mats have already been pulled. Restoration should occur when work here is complete. 4/12-5/10/06	-Needs attention when work is complete
Trench and foundation construction	- Work at the jack and bore of East Swamp Brook located at the intersection of Plumtrees Rd. Walnut Hill Rd. and Whittlesey Dr. is ongoing. Sheet piling/shoring is in place on both sides of the intersection. 2/2-5/10/06	- The area remains well contained at this time but the operation is running into significant problems with keeping water out of the trench. The grout injections didn't work as anticipated. Other options are being evaluated. 4/26-5/10/06	-N/A
	-Work is complete in the pull-off near vault 2a and b and the area should be restored. 5/10/06	-See EC section for more details. 5/10/06	-N/A

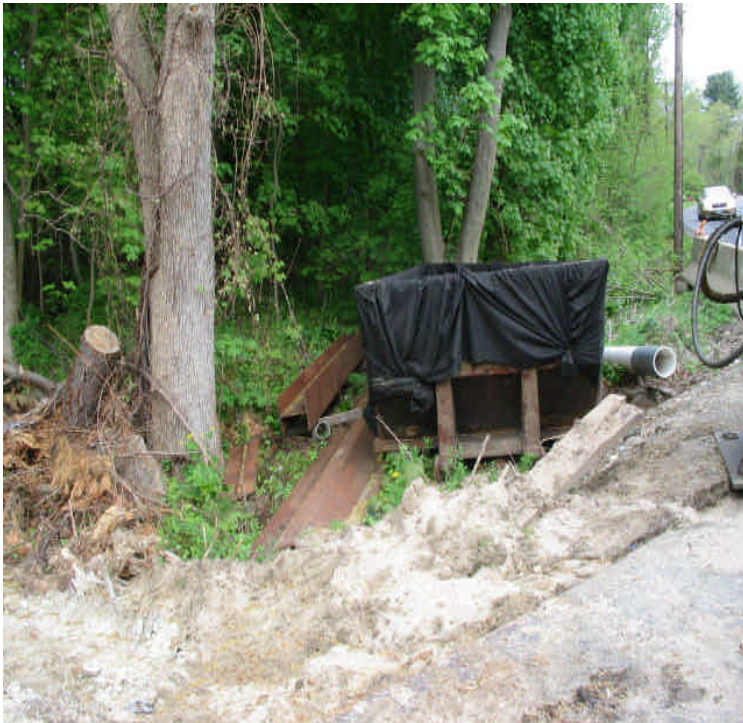
Areas of Inspection	Observation	Recommended Action	Corrective Action
	-Brush and some scrap sheet piling were noted in a wetland area around the dewatering box at the receiving pit of the J&B. 5/10/06	and stored before leaving for the day. - Continue to keep all vehicles maintained well (i.e. no apparent fluid leaks) if they will be used or stored on site. - Consider cleaning these materials up as wetland vegetation is growing in here. 5/10/06	- Needs attention if feasible

(Jack & Bore) Photo on the left shows some materials placed in a wetland area adjacent to the receiving pit. Clean up the area when feasible. Photo on the right shows the ball park area where silt fence was installed adjacent to stored materials. 5/10/06

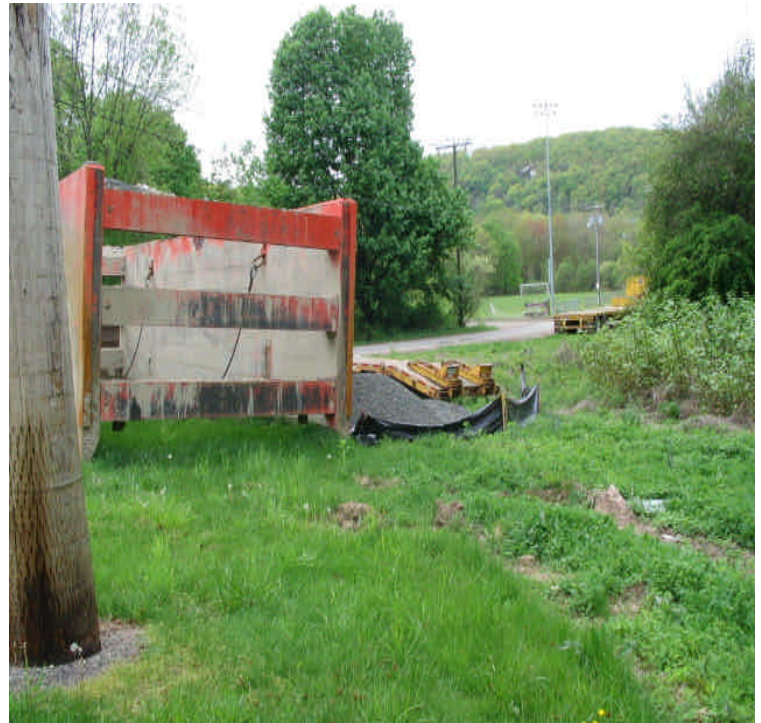
Areas of Inspection	Observation	Recommended Action	Corrective Action
<p>Whittlesey Dr and Judd Ave</p> <p>Hoyts Hill</p>	<p>- Silt fence was installed adjacent to some stored materials at the ball park. 5/10/06</p> <p>- Previously disturbed areas adjacent to the trench were being graded and restored. 5/10/06</p> <p>-Equipment was still located in the area of vault 5. 5/4-5/10/06</p> <p>- Transition station contractors repaired the tracks they made along the EC blankets. 5/10/06</p> <p>-Equipment tracking was noted in the wetland beyond the stone access where mats had previously been. 4/19-5/10/06</p>	<p>5/4-5/10/06</p> <p>- None at this time. 5/10/06</p> <p>- Continue to restore and revegetate these areas. 5/10/06</p> <p>- The area will continue to be accessed but should be restored when feasible. 5/10/06</p> <p>-None at this time. The slope is becoming stable. 5/10/06</p> <p>- Mats may have been removed prematurely. The wetland surface should be restored when work is complete here. 4/19-5/10/06</p>	<p>- Silt fence was installed proactively.</p> <p>- Restoration was occurring.</p> <p>- N/A</p> <p>- N/A</p> <p>-Needs attention when work is complete</p>

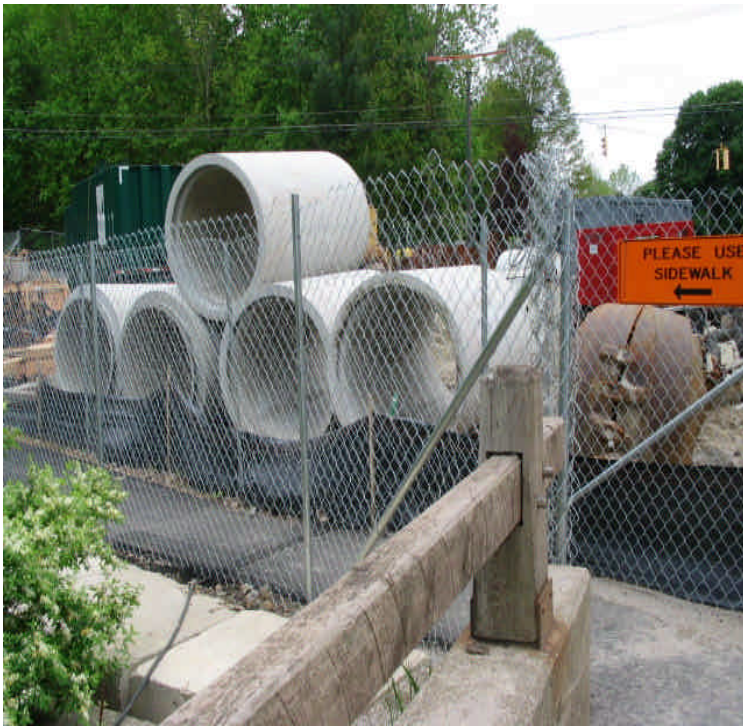
Photo on the left shows a view of the jacking pad with erosion controls in place. Photo on the right shows some of the curb, sidewalk and landscaping restoration efforts along Whittlesey Drive. 5/10/06

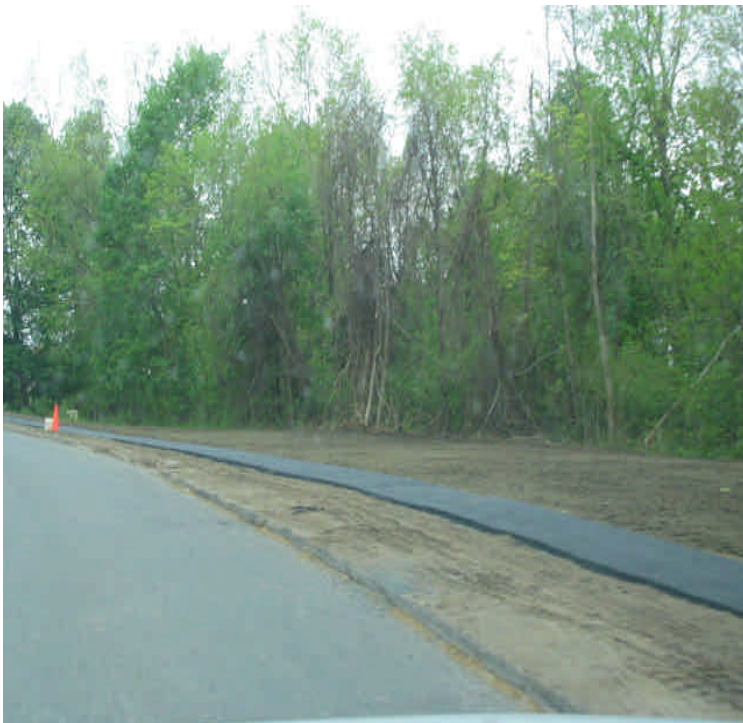
Photo on the left shows sidewalk restoration and adjacent grading along the roadway. Photo on the right shows Hoyts Hill where the northern slope is well restored. 5/10/06

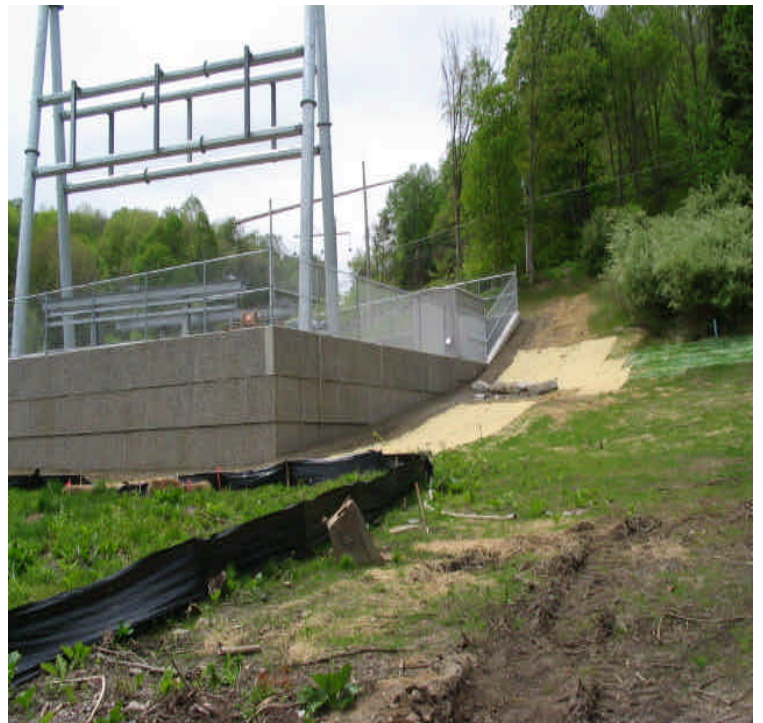
- Most roadway trench work appeared complete. Work was occurring to restore sidewalks and curbing. 5/10/06 -The trench is complete along the slope at Hoyts Hill with a small area of open trench remaining at the base. 4/6-5/10/06	- See EC section for more details. Permits are needed to continue trench work into Rt. 58. 4/26-5/10/06 - See erosion control section for more details 5/10/06	-N/A - N/A
Erosion and Sediment Controls (includes inspection within 24 hours of a storm event) Walnut Hill Rd. Jack and Bore	- Work is complete near vault 2A&B. Silt fence remains in place but the area will need some restoration. 5/10/06 - One inactive filter bag remained behind the silt fence. 4/26-5/10/06 -The plastic liner remains within the stream bed. The sandbag diversion is in place but excess water is still a problem here. 5/10/06	- Restore when feasible and keep stone surface to the minimum necessary. Allow natural revegetation where possible, especially in the area closest to the silt fence. 5/10/06 -Upon restoration, remove all materials including filter bags. 4/26-5/10/06 -The stream was still running clear at the time and will be restored eventually. New solutions are being investigated.	-Needs attention when feasible -Needs attention when feasible -N/A at the time
